Old Oakland Road Habitat Mitigation Project
Story Road Mitigation Site #2

Year 4 (2008) Monitoring Report

Kathleen Lyons, Plant Ecologist

December 15, 2008

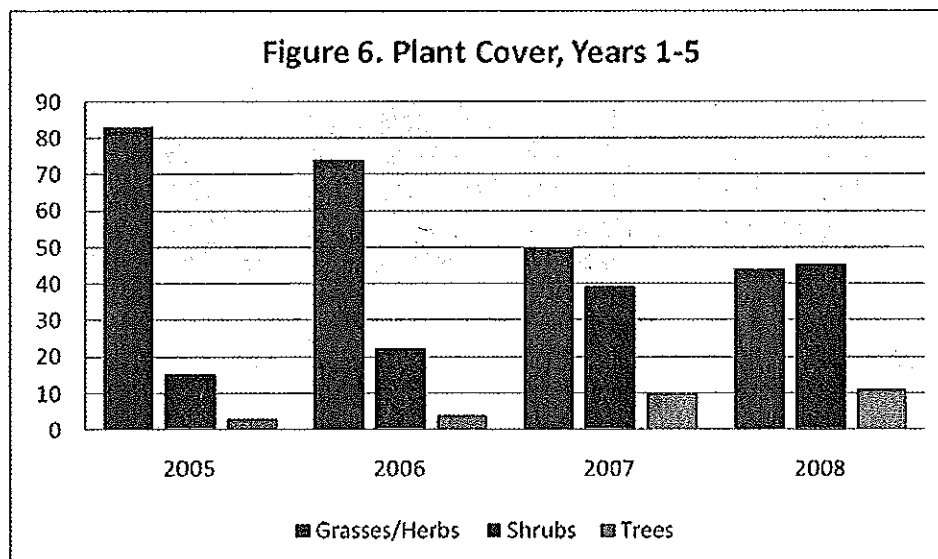
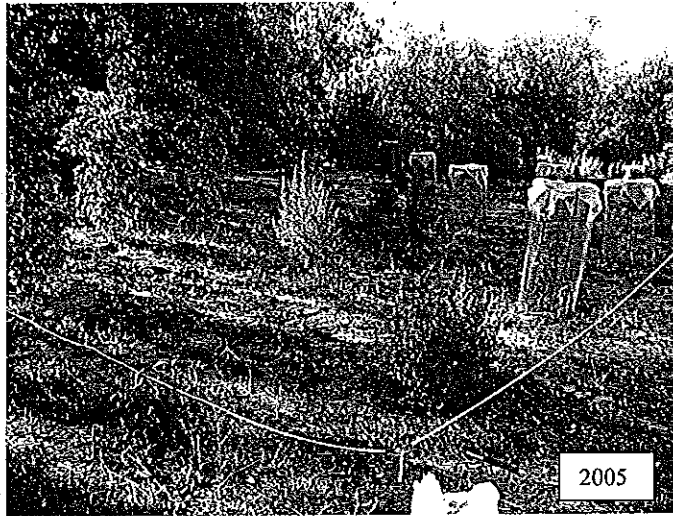
Figure 7A. View of Sample Plot 1, October 2005. Sample plot contains 7 plants; 3 coyote brush, 1 blackberry and 2 box elders. One empty planting area was noted. Herbaceous/bare cover is 80%; shrub cover is 10% and tree cover is 10%.

Figure 7B. View of Sample Plot 1, September 2007. Herbaceous/bare cover is 25%; shrub cover is 60% and tree cover is 15%.

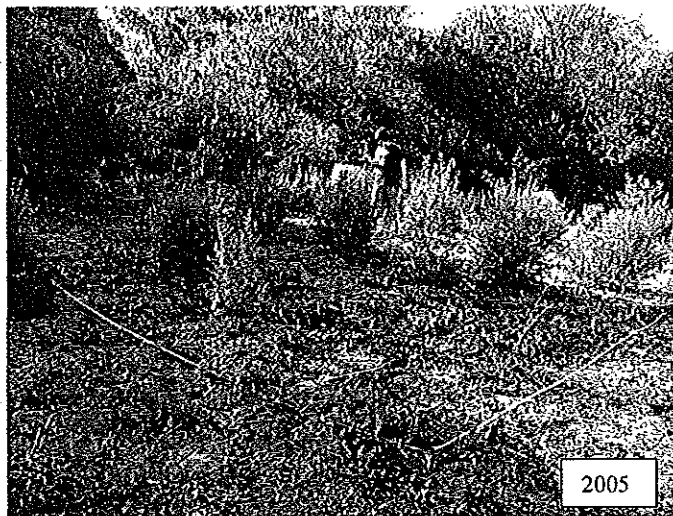
Figure 8A. View of Sample Plot 2, October 2005. Sample plot contains 14 plants (all alive), consisting of 7 blackberries and 7 coyote brush. Herbaceous/bare cover is 60%; shrub cover is 40% and tree cover is 0%.

Figure 8B. View of Sample Plot 2, September 2008. Herbaceous/bare cover is 5%; shrub cover is 90% and tree cover is 0%. Weeds include tree-of-heaven.

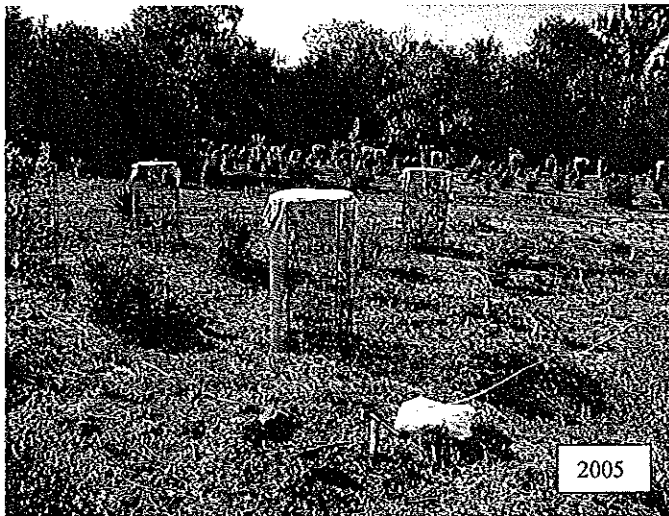
Figure 9A. View of Sample Plot 3, October 2005. Sample plot contains 10 plantings (all alive), consisting of 4 coyote brush, 2 coast live oaks, 3 blackberries and 1 sycamore. Herbaceous/bare cover is 79%; shrub cover is 20% and tree cover is 1%.

Figure 9B. View of Sample Plot 3, September 2008. Herbaceous/bare cover is 10%; shrub cover is 75% and tree cover is 15%.

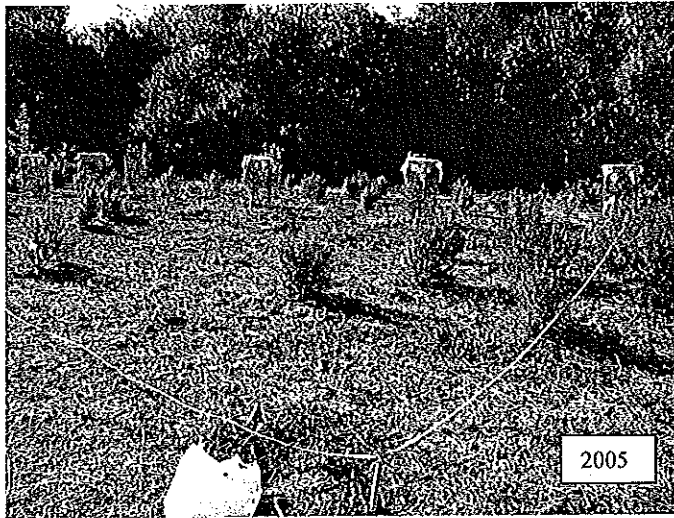
Figure 10A. View of Sample Plot 4, October 2005. Sample plot contains 7 plantings (all alive), consisting of 7 coyote brush. Herbaceous/bare cover is 60%; shrub cover is 40% and tree cover is 0%.

Figure 10B. View of Sample Plot 4, September 2008. Herbaceous/bare cover is 30%; shrub cover is 70% and tree cover is 0%.

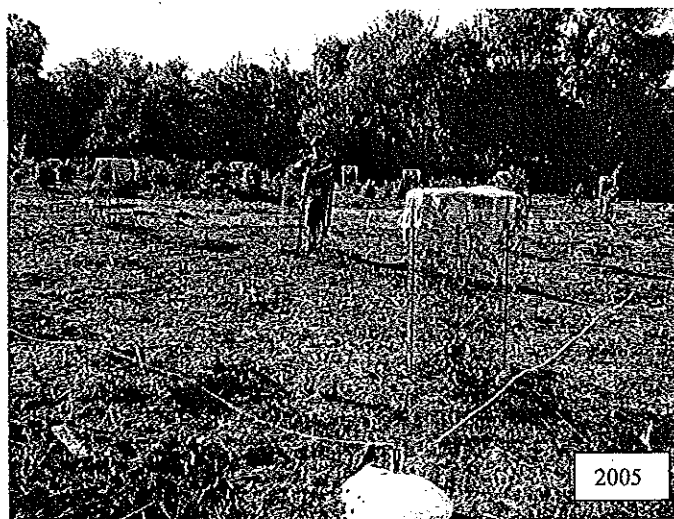
Figure 11A. View of Sample Plot 5, October 2005. Sample plot contains 10 plantings (8 alive, 2 dead), consisting of 1 blackberry, 3 sycamore, 4 snowberry and 2 empty sites. Herbaceous/bare cover is 98%; shrub cover is 1% and tree cover is 1%.

Figure 11B. View of Sample Plot 5, September 2008. Herbaceous/bare cover is 40%; shrub cover is 30% and tree cover is 30%.

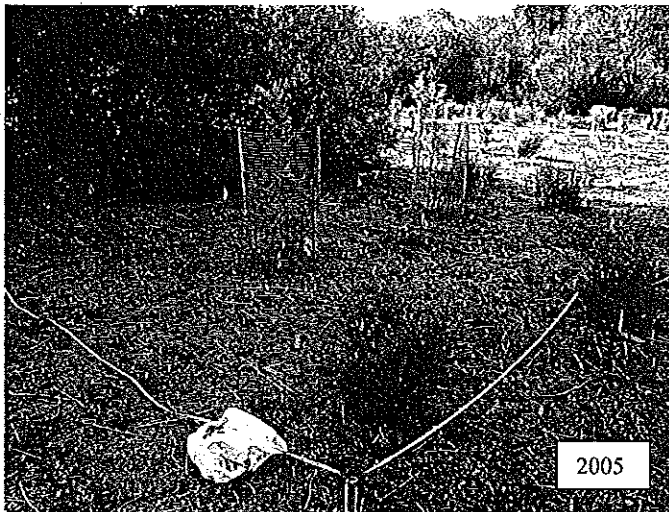
Figure 12A. View of Sample Plot 6, October 2005. Sample plot contains 5 plantings (all alive), consisting of 1 coyote brush, 1 blackberry, 1 coast live oak, 1 willow and 1 sycamore. Herbaceous/bare cover is 94%; shrub cover is 5% and tree cover is 1%.

Figure 12B. View of Sample Plot 6, September 2008. Herbaceous/bare cover is 50%; shrub cover is 30% and tree cover is 20%.

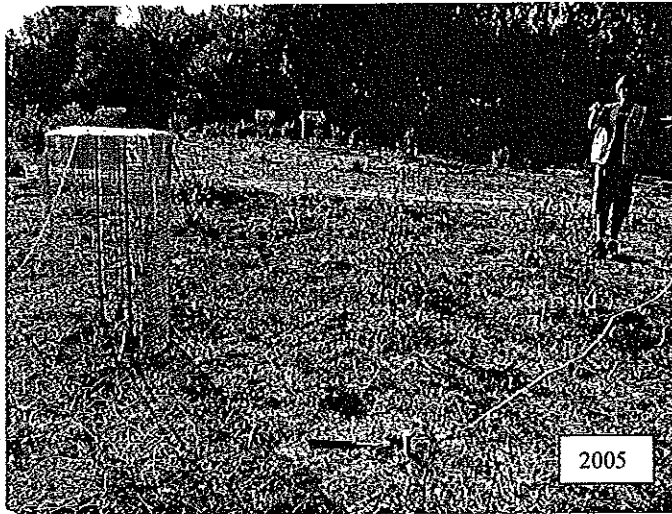
Figure 13A. View of Sample Plot 7, October 2005. Sample plot contains 9 plantings (all alive), consisting of 9 snowberries. Herbaceous/bare cover is 80%; shrub cover is 20% and tree cover is 0%.

Figure 13B. View of Sample Plot 7, September 2008. Herbaceous/bare cover is 40%; shrub cover is 50% and tree cover is 10%.

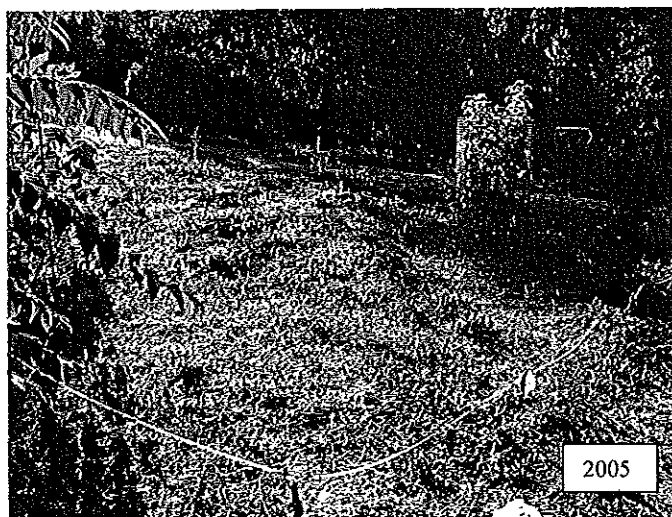
Figure 14A. View of Sample Plot 8, October 2005. Sample plot contains 5 plantings (all alive), consisting of 1 box elder, 3 snowberries and 1 sycamore. Herbaceous/bare cover is 94%; shrub cover is 1% and tree cover is 5%.

Figure 14B. View of Sample Plot 8, September 2008. Herbaceous/bare cover is 30%; shrub cover is 50% and tree cover is 20%.

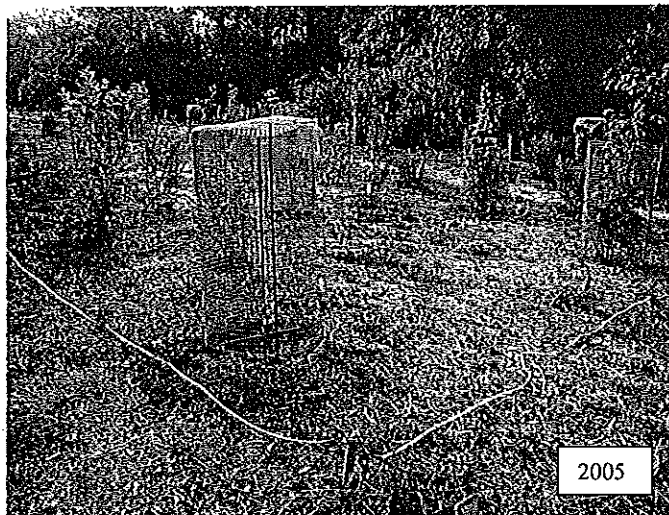
Figure 15A. View of Sample Plot 9, October 2005. Sample plot contains 10 plantings (9 alive, 1 dead), consisting of 2 buckeyes, 2 blackberries, 1 box elder, 4 coyote brush and 1 empty site. Herbaceous/bare cover is 79%; shrub cover is 20% and tree cover is 1%.

Figure 15B. View of Sample Plot 9, September 2008. Herbaceous/bare cover is 40%; shrub cover is 50% and tree cover is 10%.

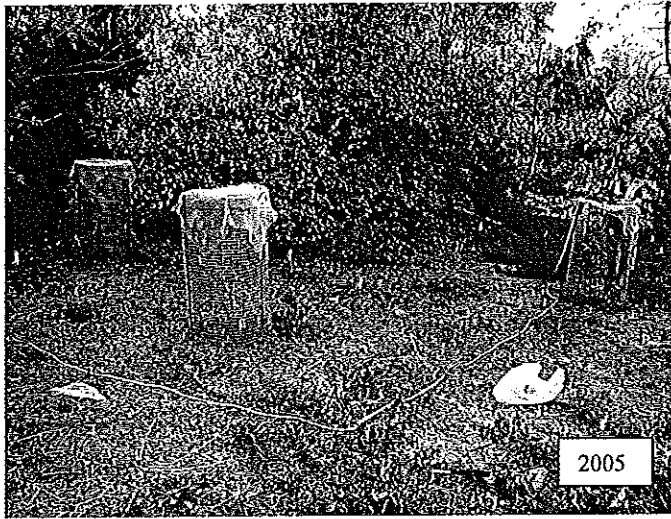
Figure 16A. View of Sample Plot 10, October 2005. Sample plot contains 11 plantings (8 alive, 3 dead), consisting of 5 snowberry, 1 coyote brush, 1 blue elderberry, 1 buckeye and 3 empty sites. Herbaceous/bare cover is 90%; shrub cover is 5% and tree cover is 5%.

Figure 16B. View of Sample Plot 10, September 2007. Herbaceous/bare cover is 50%; shrub cover is 40% and tree cover is 10%.

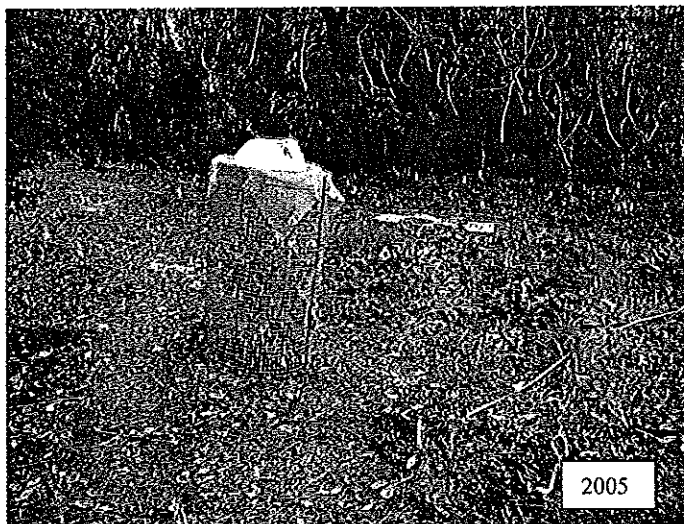
Figure 17A. View of Sample Plot 11, October 2005. Sample plot contains 8 plantings (7 alive, 1 dead), consisting of 1 box elder, 6 snowberries and 1 empty site. Herbaceous/bare cover is 90%; shrub cover is 5%, tree cover is 5%.

Figure 17B. View of Sample Plot 11, September 2008. Herbaceous/bare cover is 75%; shrub cover is 20%, tree cover is 5%.

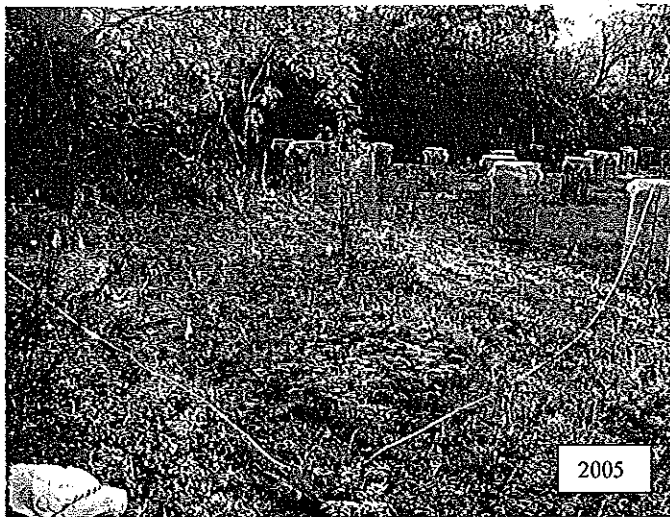
Figure 18A. View of Sample Plot 12, October 2005. Sample plot contains 12 plantings (11 alive, 1 dead), consisting of 2 mugwort, 7 snowberries, 1 box elder, 1 buckeye and 1 empty site. Herbaceous/bare cover is 89%; shrub cover is 10%, tree cover is 1%.

Figure 18B. View of Sample Plot 12, September 2008. Herbaceous/bare cover is 20%; shrub cover is 75%, tree cover is 10%.

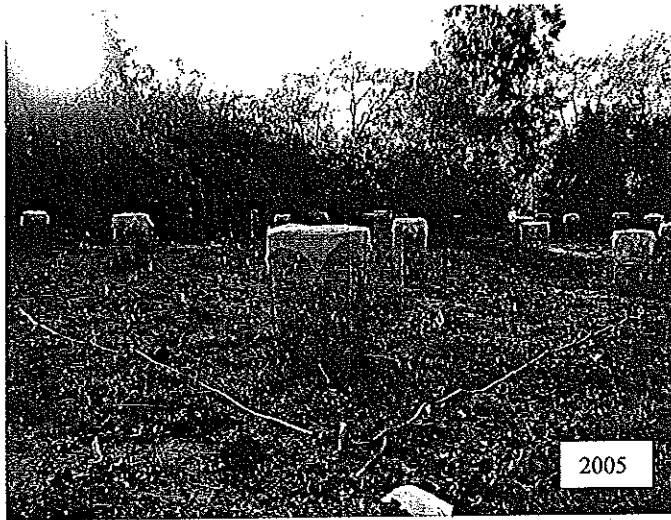
Figure 19A. View of Sample Plot 13, October 2005. Sample plot contains 10 plantings (9 alive, 1 dead), consisting of 5 snowberries, 1 coast live oak, 1 blue elderberry, 1 box elder, 1 coyote brush and 1 empty site. Herbaceous/bare cover is 94%; shrub cover is 5%, tree cover is 1%.

Figure 19B. View of Sample Plot 13, September 2008. Herbaceous/bare cover is 75%; shrub cover is 20%, tree cover is 10%.

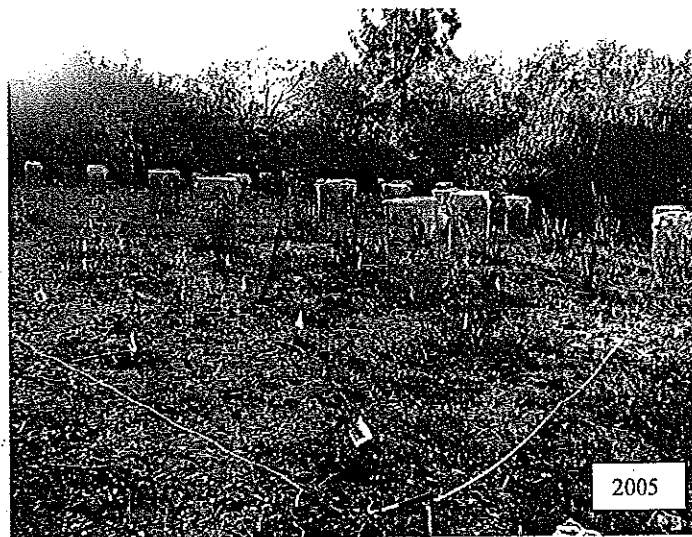
Figure 20A. View of Sample Plot 14, October 2005. Sample plot contains 10 plantings (9 alive, 1 dead), consisting of 8 mugwort, 1 blue elderberry, and 1 empty site. Herbaceous/bare cover is 90%; shrub cover is 10%, tree cover is 0%.

Figure 20B. View of Sample Plot 14, September 2008. Herbaceous cover and bare is 90%; shrub cover is 10%, tree cover is 0%. Weeds include tree-of-heaven.

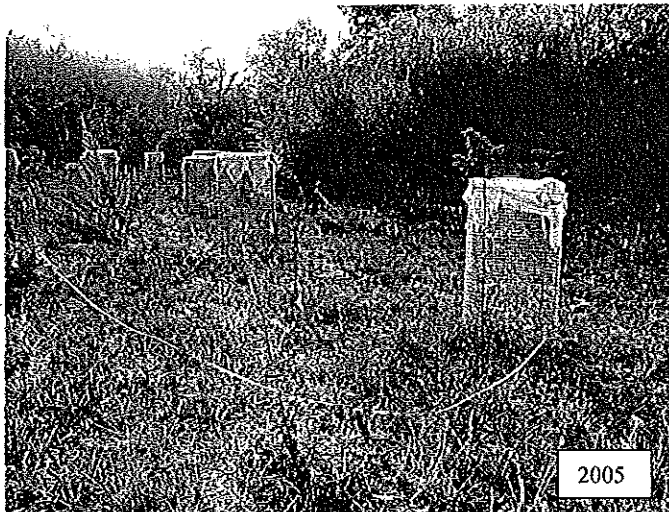
Figure 21A. View of Sample Plot 15, October 2005. Sample plot contains 8 plantings (all alive), consisting of 6 mugwort and 2 buckeyes. Herbaceous/bare cover is 60%; shrub cover is 39%, tree cover is 1%.

Figure 21B. View of Sample Plot 15, September 2008. Herbaceous/bare cover is 80%; shrub cover is 10%, tree cover is 10%.
